# 南九十九里浜の海岸侵食

日本大学工学部客員教授  
宇多 高明

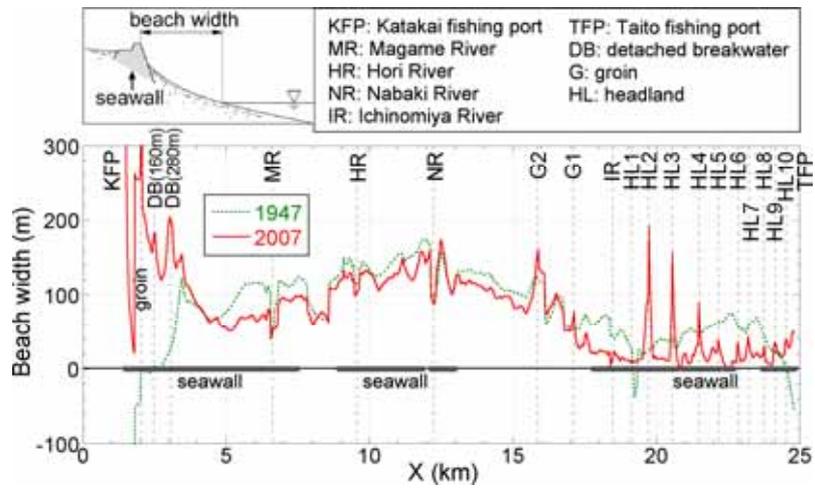
Figure 3. Change in beach width between 1947 and 2007 measured from seawall line in 2007.

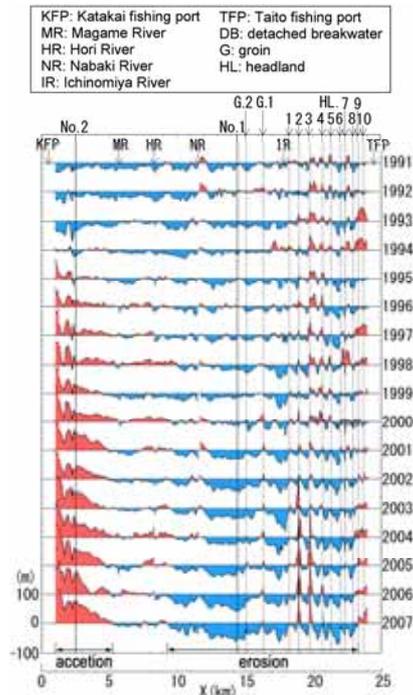
Figure 4. Shoreline changes of south Kujukuri Beach between 1990 and 2007.<sup>11</sup>

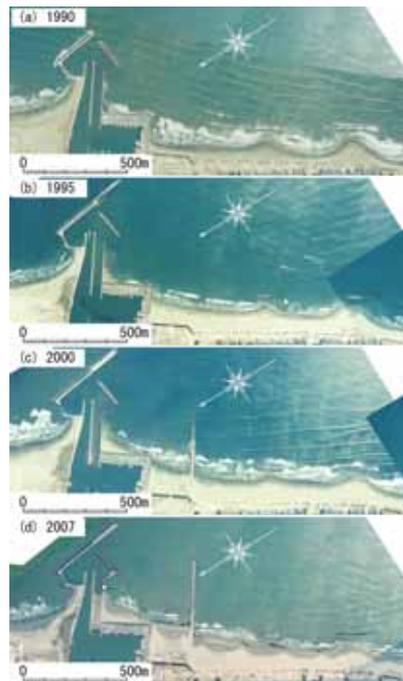
Figure 5. Aerial photographs of Katakai fishing port.

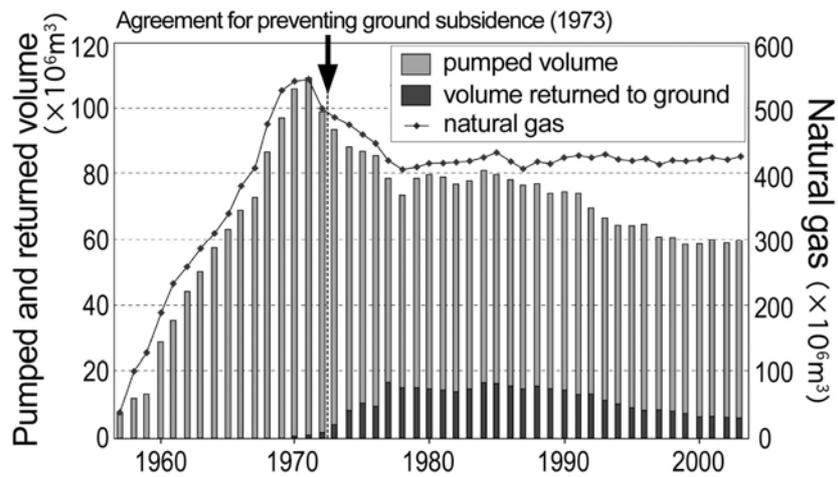
Figure 7. Volume changes in underground water that was pumped-up and returned to layer, and changes in production of water-soluble gas.

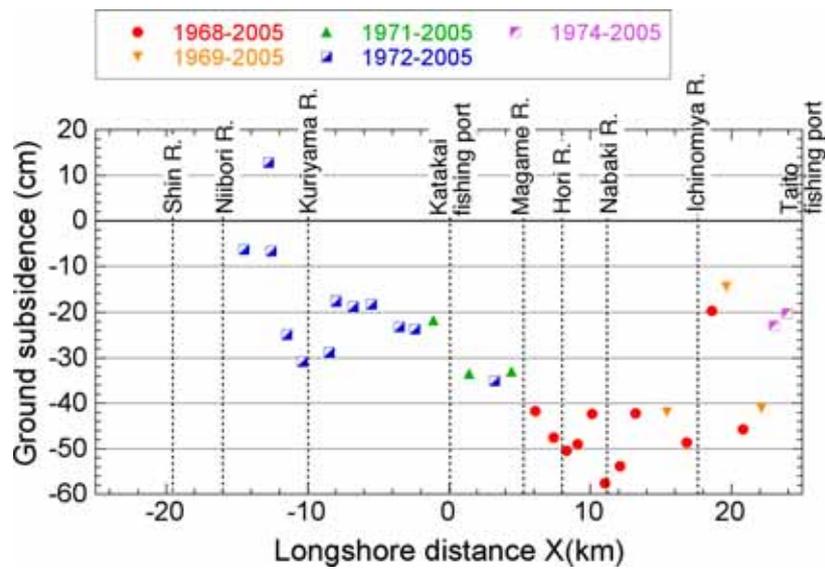
Figure 8. Cumulative subsidence of ground level at bench marks near shoreline.

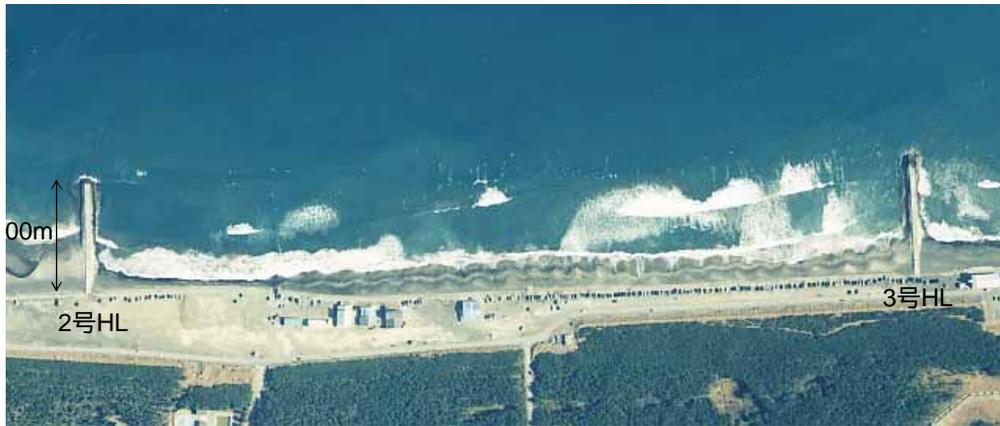
2000年1月

## 2,3号HLの形状と汀線変化
